KSC Ice/Frost/Debris Assessment For Space Shuttle Mission STS-29R

Charles G. Stevenson
NASA/Kennedy Space Center

KSC ICE/FROST/DEBRIS ASSESSMENT
FOR
SPACE SHUTTLE MISSION
STS-29R
MARCH 13, 1989

Approved:
April 30, 1989

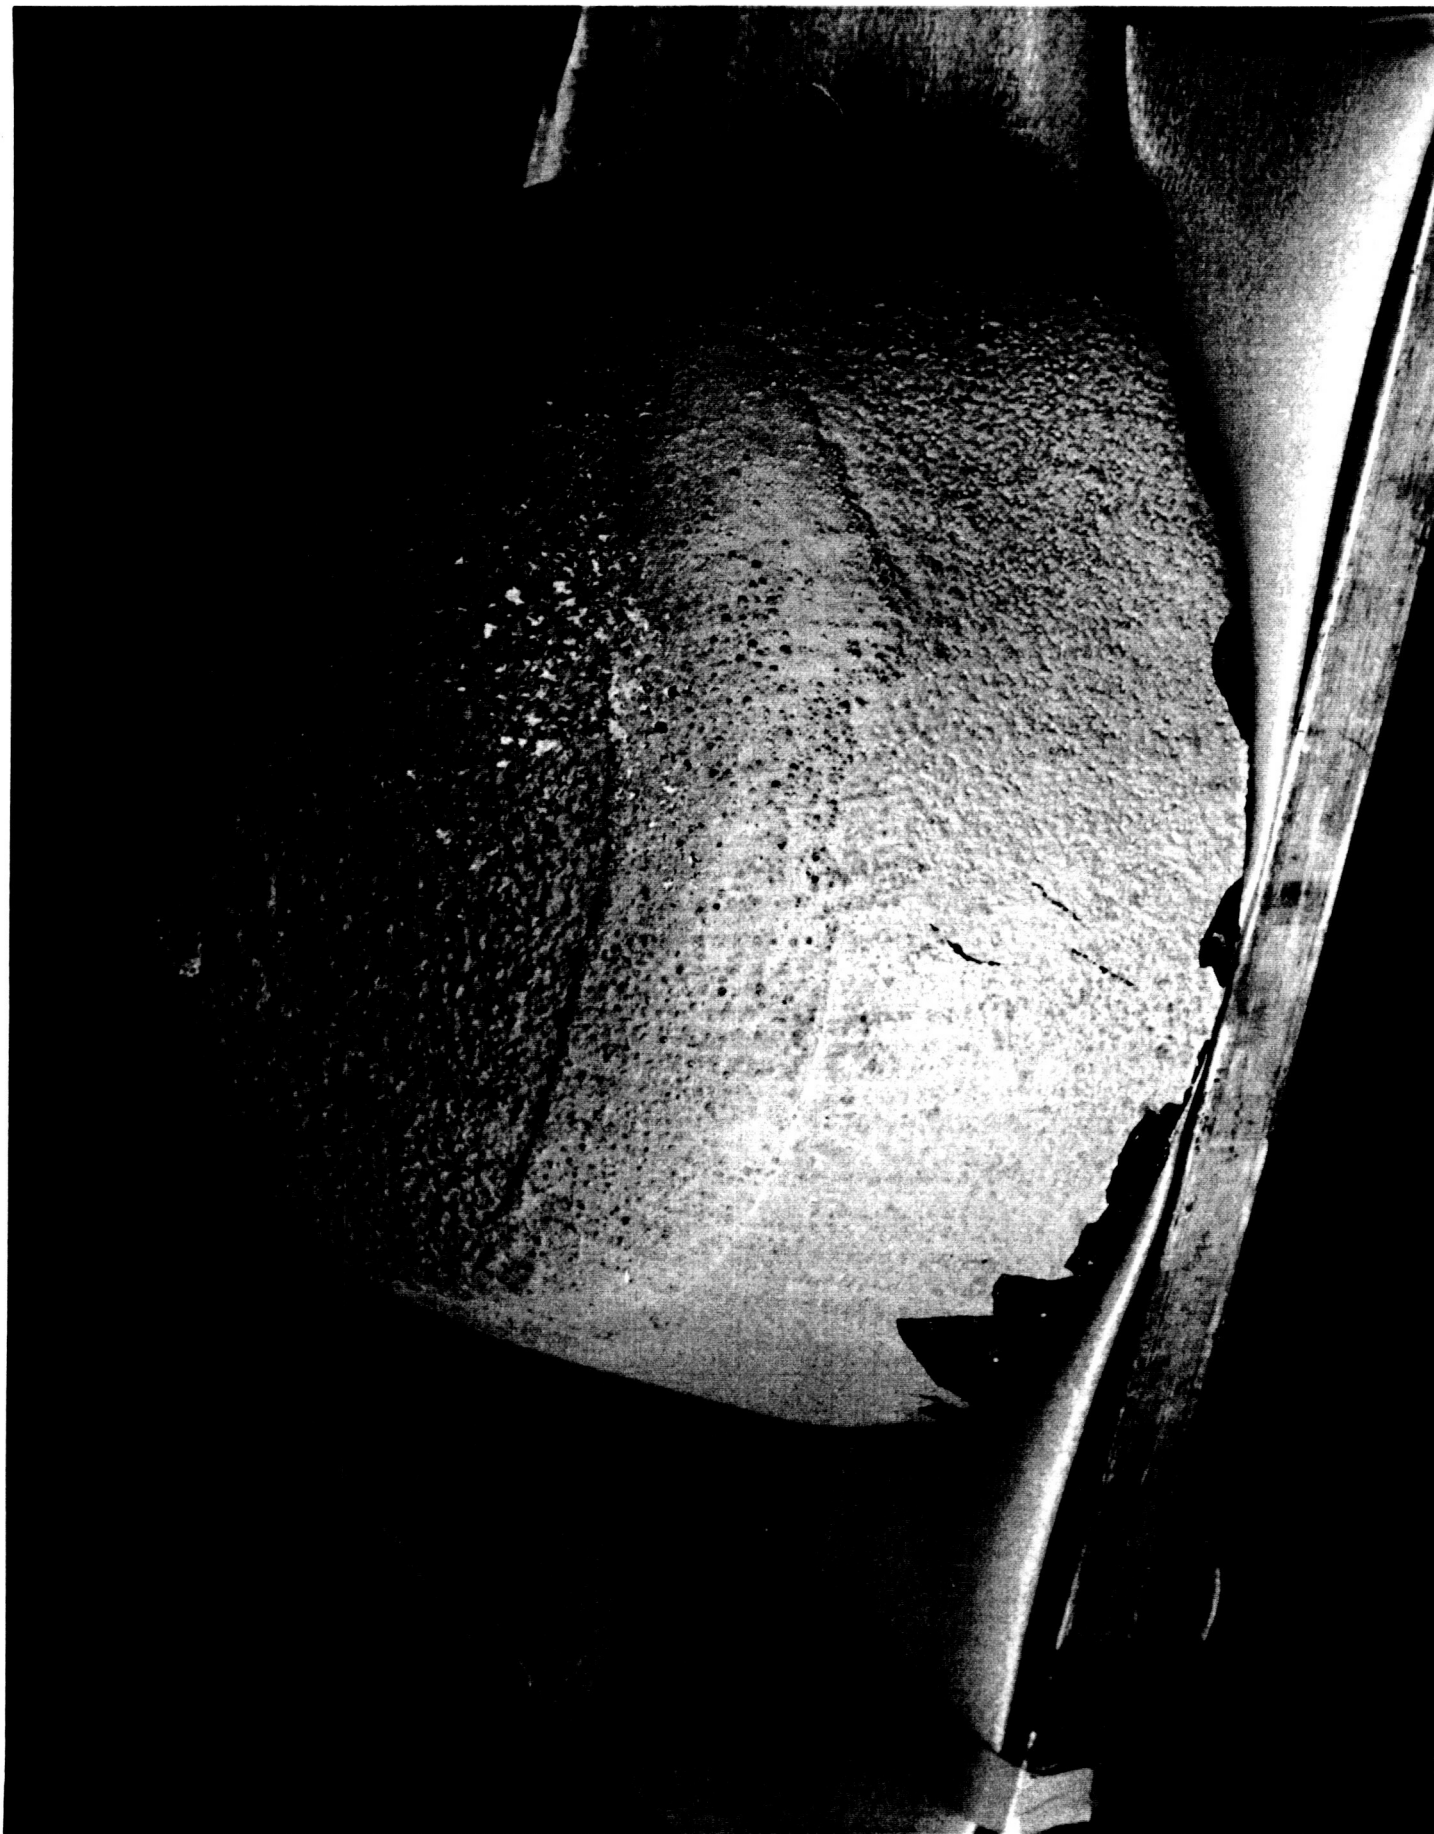
ALTHOUGH NOT USUALLY RECOVERED, THIS LH SRB NOSE CAP DOME
EXHIBITS NO ABLATOR ADHESION PLOBLEMS

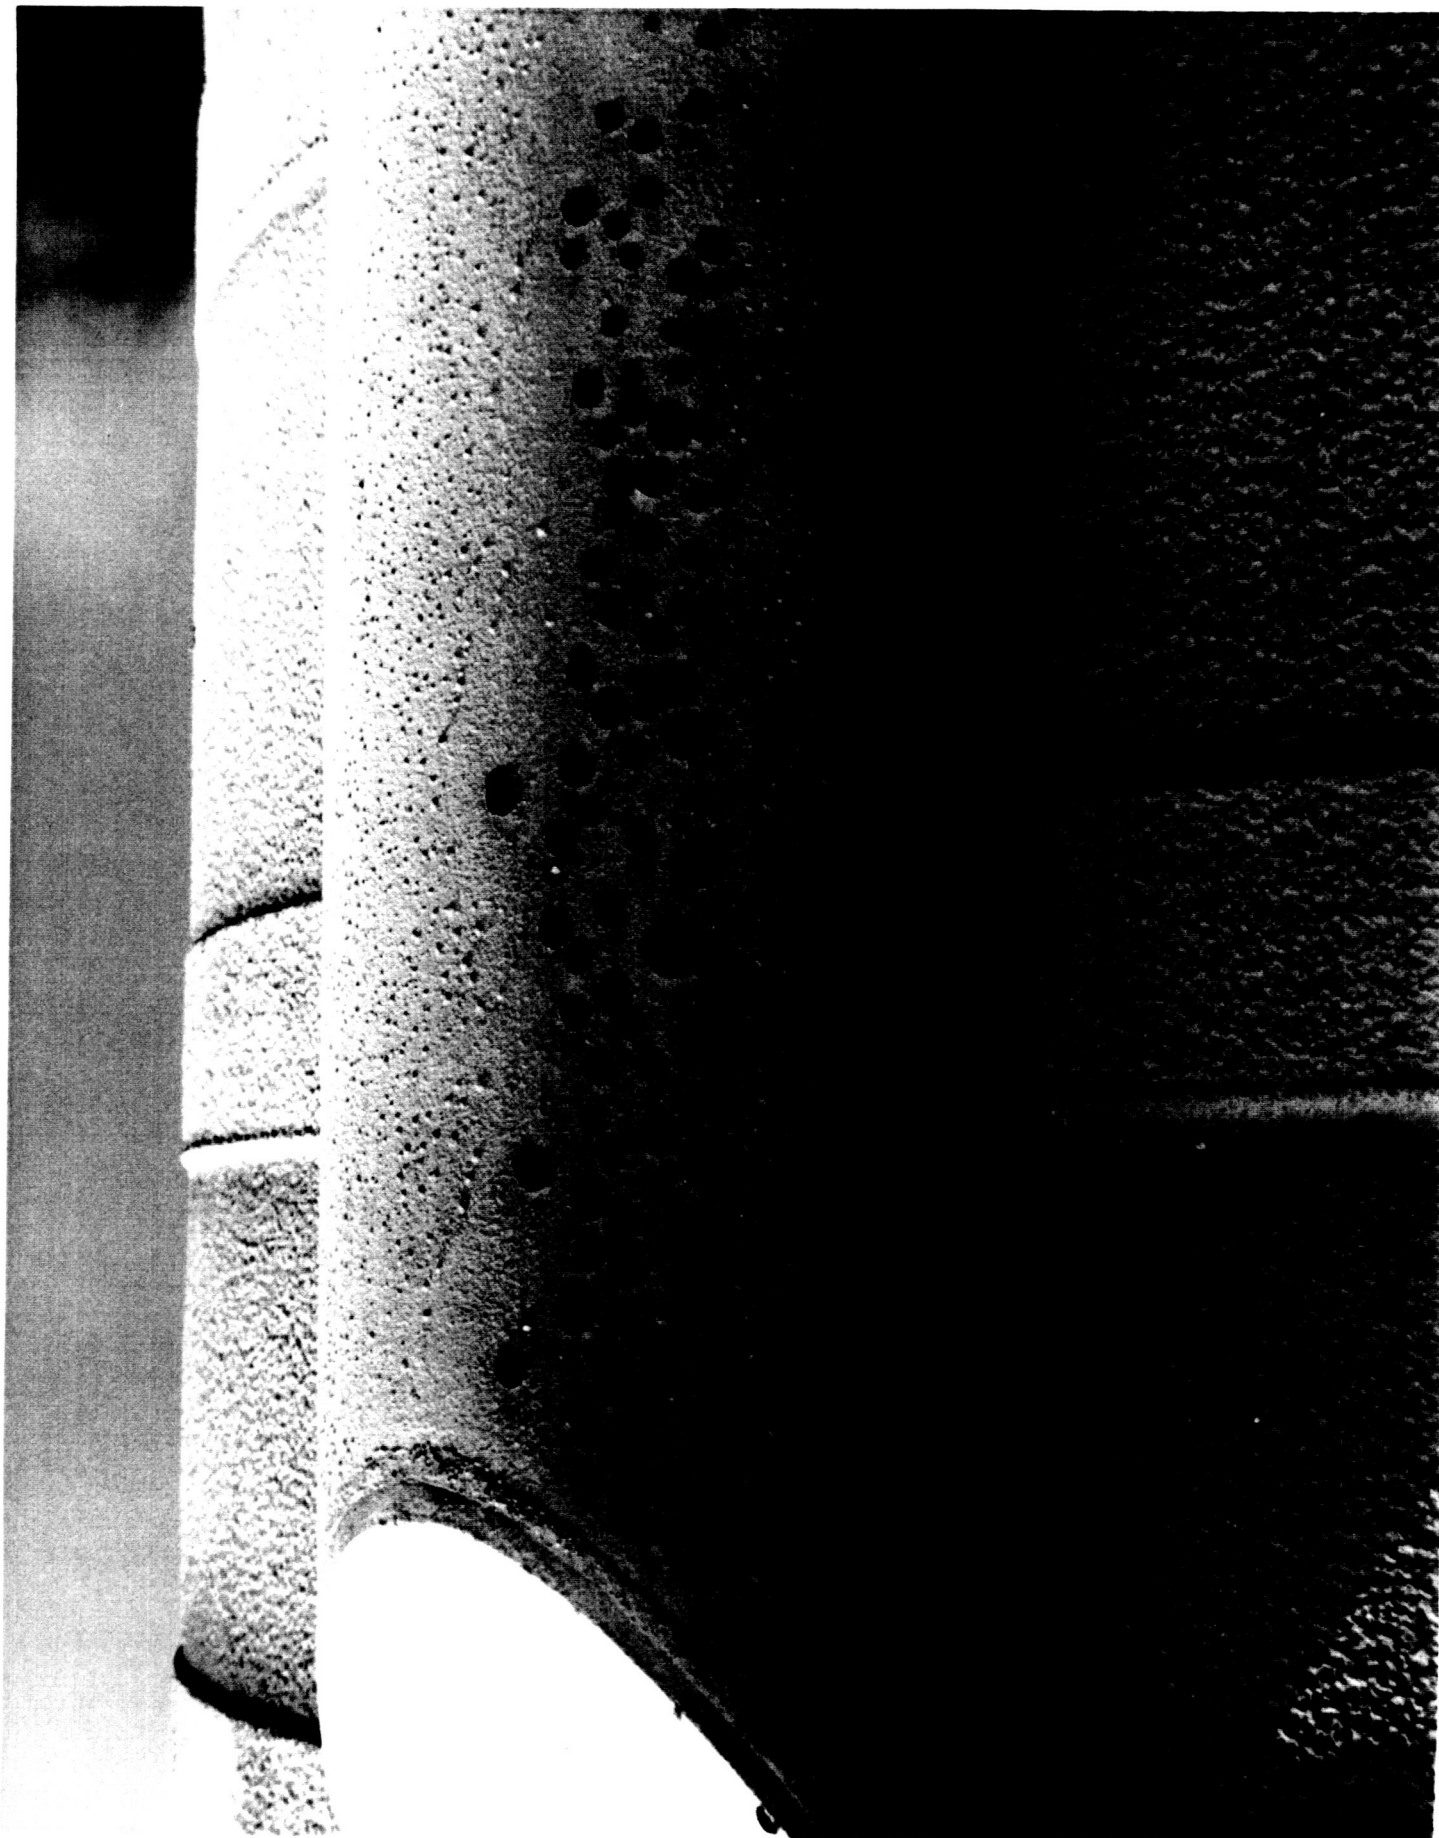
BLISTERING OF THE PAINT/CORK AS LARGE AS 1-INCH IN
DIAMETER OCCURRED ON THE RH SRB SYSTEMS TUNNEL COVER

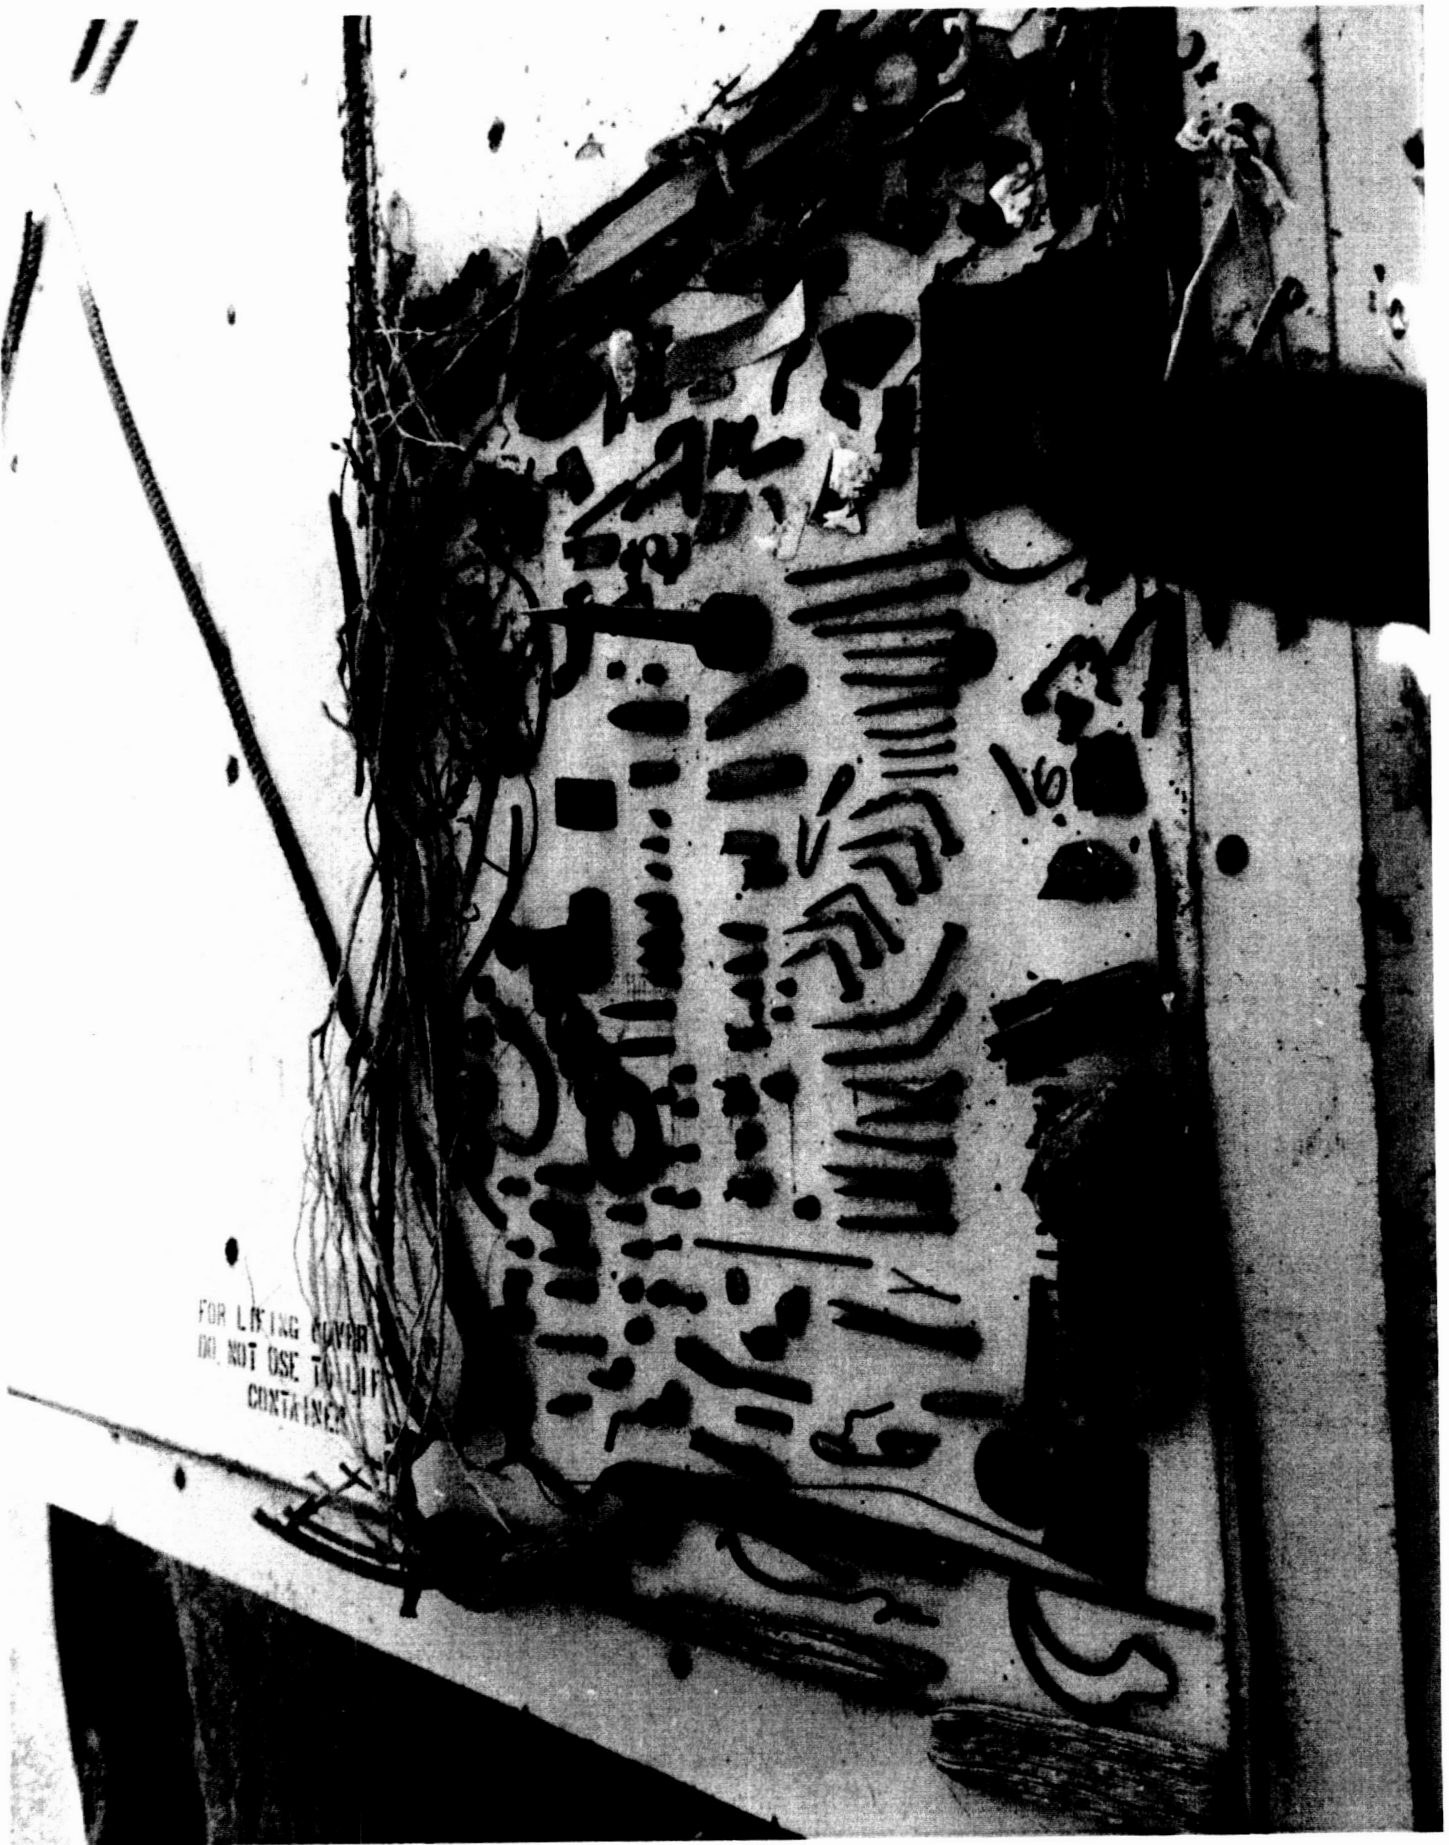
DEBRIS COLLECTED DURING PRE-LANDING RUNWAY WALKDOWN

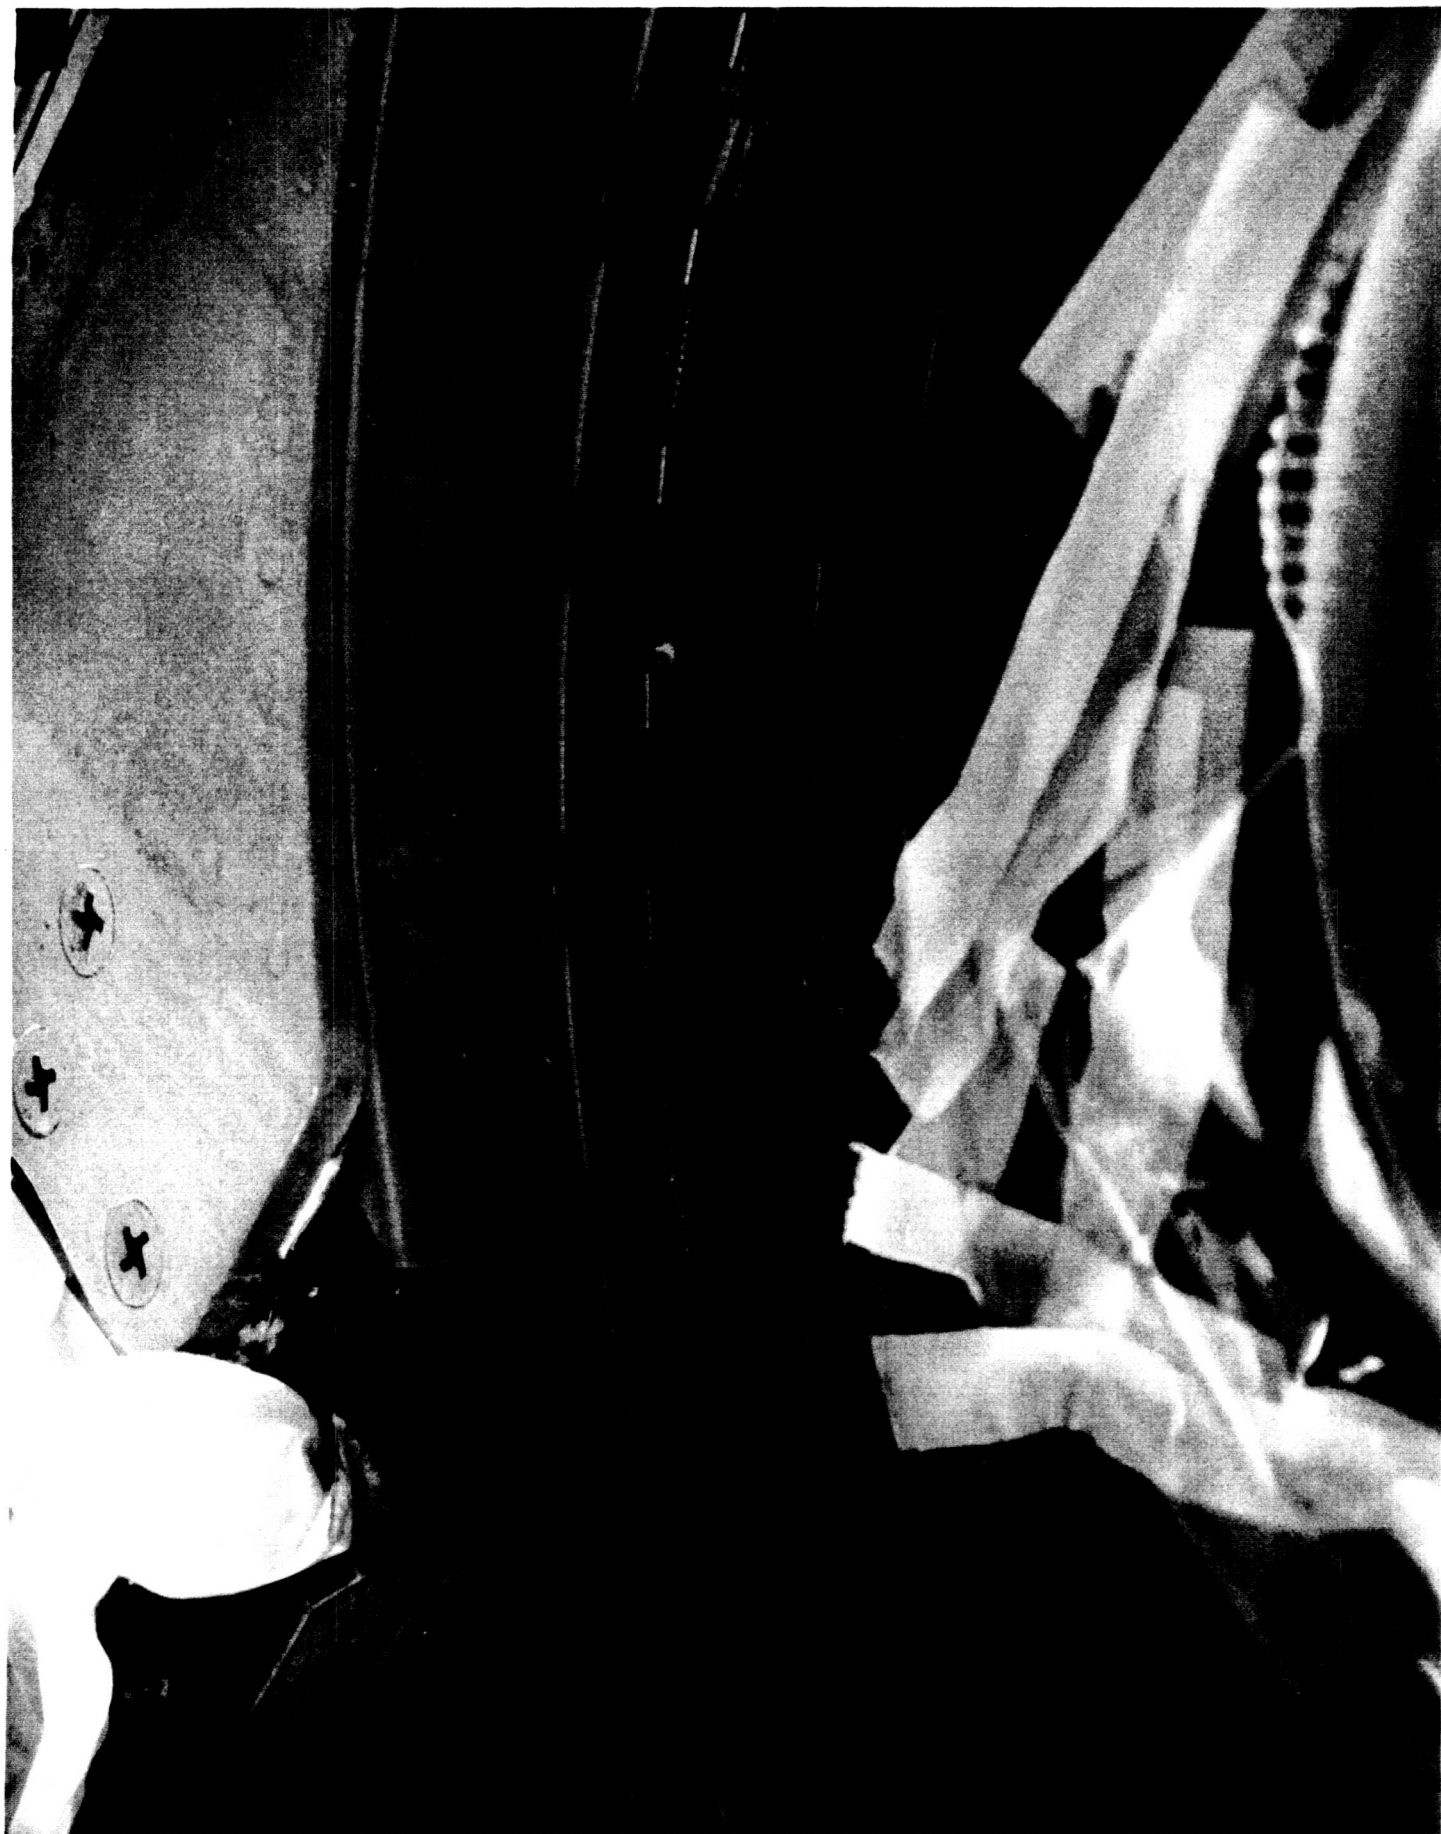
SMALL PARTICLES OF SOFI IMBEDDED IN UMBILICAL SPRINGS

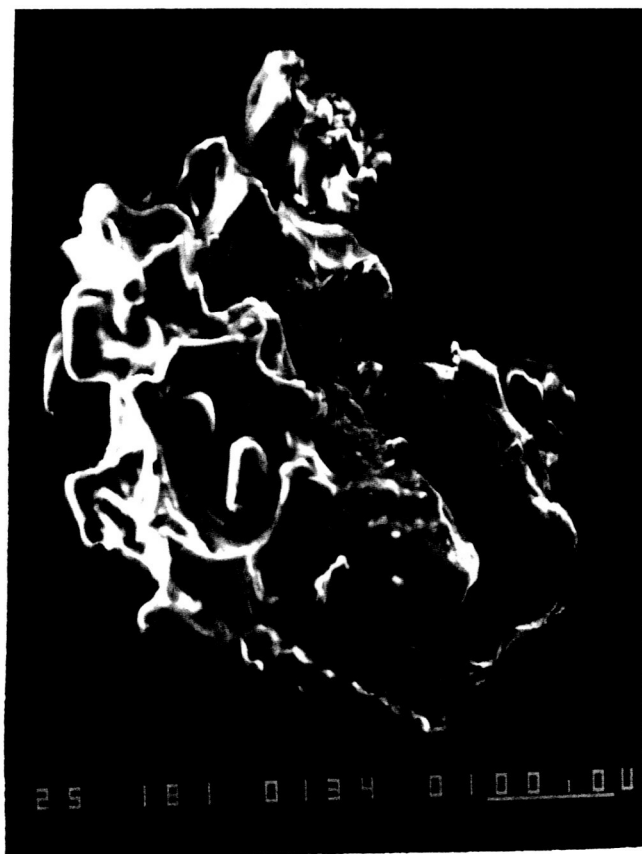
2.2.4 Figures 3 and 4 are low magnification SEM photomicrographs of black tile debris to show the surface characteristics.

Figure 3
SEM Photomicrograph of Black Tile to Show
the Fused Appearance, 2C. 160X

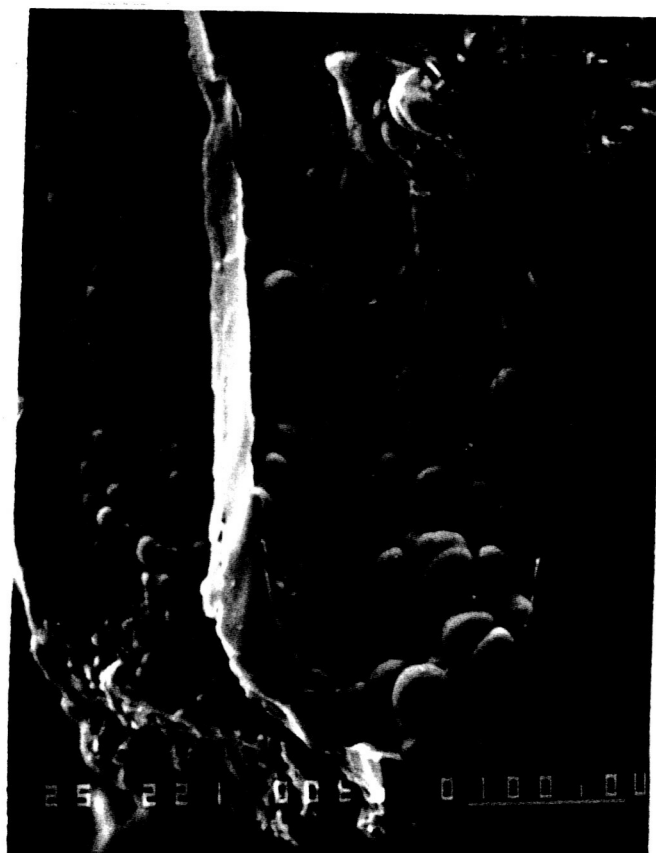
Figure 4
SEM Photomicrograph of Black Tile Surface
to Show the Spherical Appearance of Fused
Tile. 1246, 220X

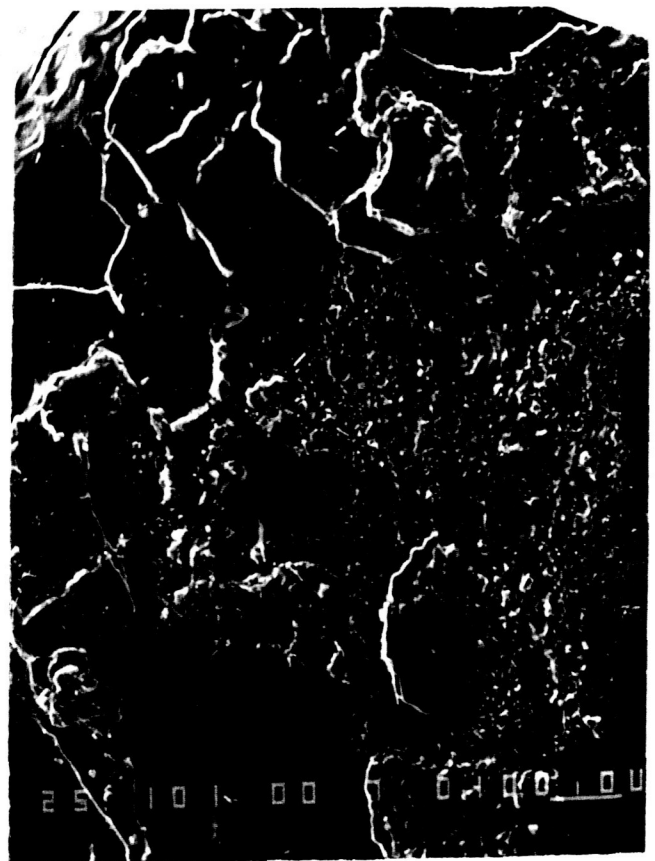
2.2.6 Figure 6 is low magnification SEM photomicrograph of the white haze deposits on the black tile surface. Some of the white clear and white haze deposits were identified to be alpha-cristobalite (SiO₂).

Figure 6
SEM Photomicrograph of the White Haze
Deposits on the Black Tile Surface.
0279. 100X

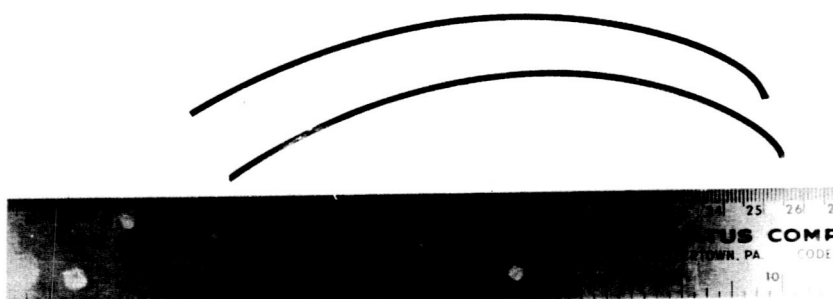
The wire is probably a carbon steel flux cored welding electrode, origin unknown. Core materials found are consistent with the types of materials used in flux cored electrodes with the exception of Sr (strontium), which was not listed in the welding references checked. However, flux materials are proprietary substances and Sr could be included as an undisclosed element.

Overall photograph of two wires submitted for analysis

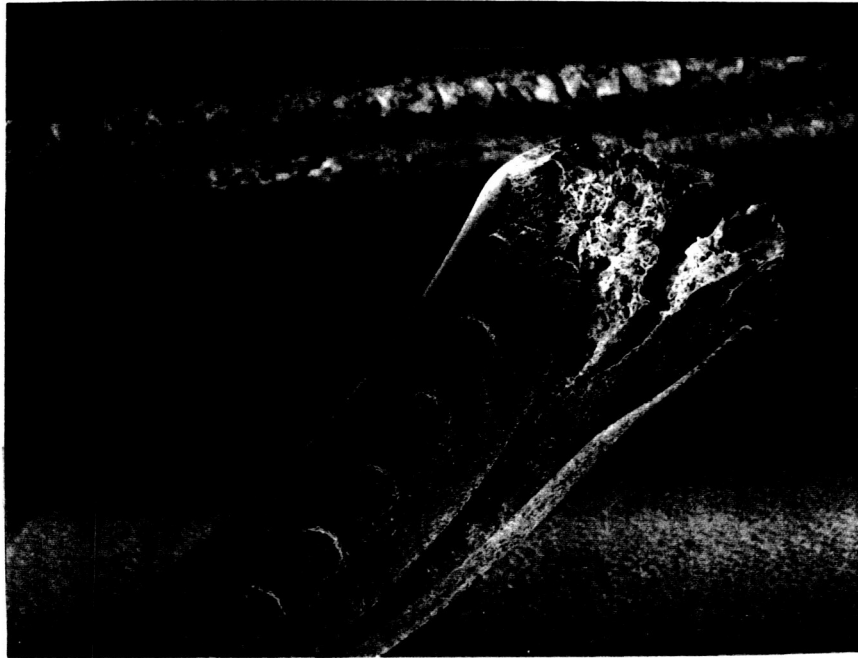
Wire, showing split end and flux core.
